Operator Eliminates Sustained Casing Pressure in Injector Well

Remedial cementing with CemFIT Heal system and expanding agent restores integrity to 17-year-old well, enabling injection to resume, Prudhoe Bay

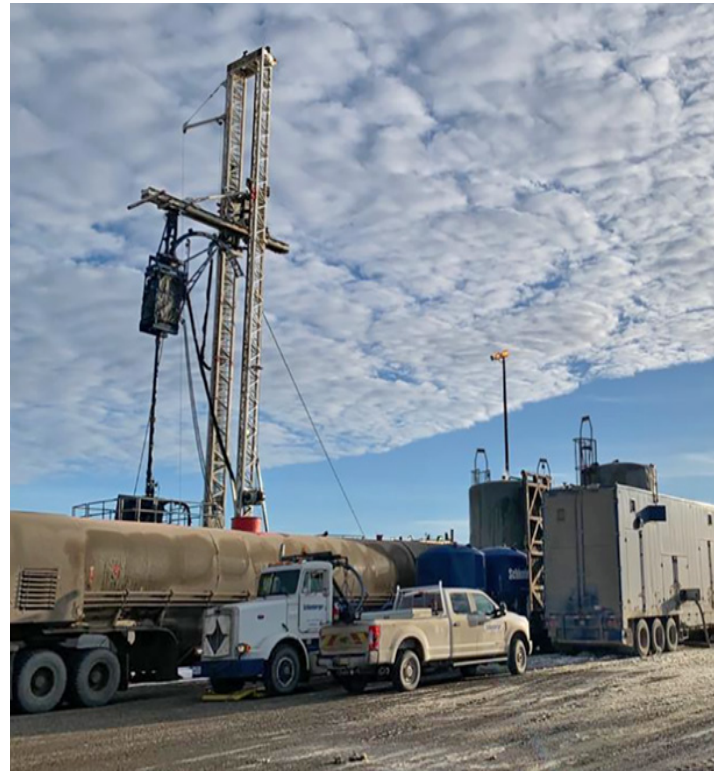
The operator managed SCP in a challenging field with a CT squeeze of CemFIT Heal system, which has high flexibility under stress and an ability to heal any cracks that form.
