CoilFLATE and Water-Shutoff Systems Restore 75 m³/d Oil Production in Wells

CT-conveyed inflatable packers and chemical barriers isolate water production zones, enabling oil production in two wells after 10-year shut-in, West Africa

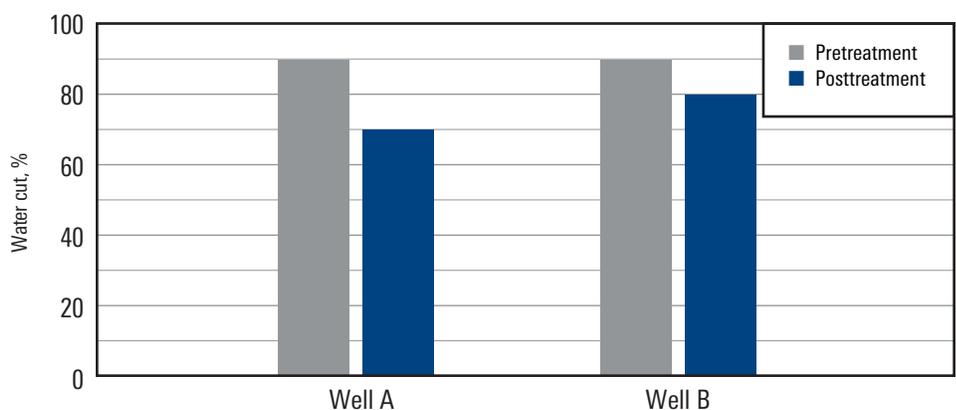
Reducing the water-cut levels of well A and well B from 90% to 70% and 80%, respectively, allowed these nonproductive wells to be put back online.
