Coil Tubing Services Helps Operator Retrieve Difficult-to-Reach Check Valve in 46 Hours, Saving USD 72,000

Operator fishes trapped two-way check valve 3 days faster than planned, avoiding a major workover

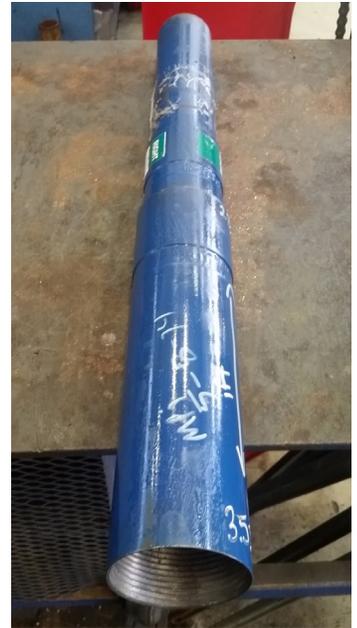
A box tap with a tapered OD was used to successfully fish the valve from the well.

Coil Tubing Services, a Schlumberger company, proposed using CoilTOOLS CT intervention tools and solutions with a faster, simpler solution—running a box tap with a tapered OD to engage the valve. After a few runs, it was determined that debris had settled above the two-way check valve and was interfering with the operation. A magnet run followed by a lead impression block run revealed the threads from the valve had fallen downhole on top of the fish. Coil Tubing Services performed a burnover operation to remove the threads, allowing the valve to be fished with the box tap as planned.
