EM Pipe Scanner

Electromagnetic casing inspection tool

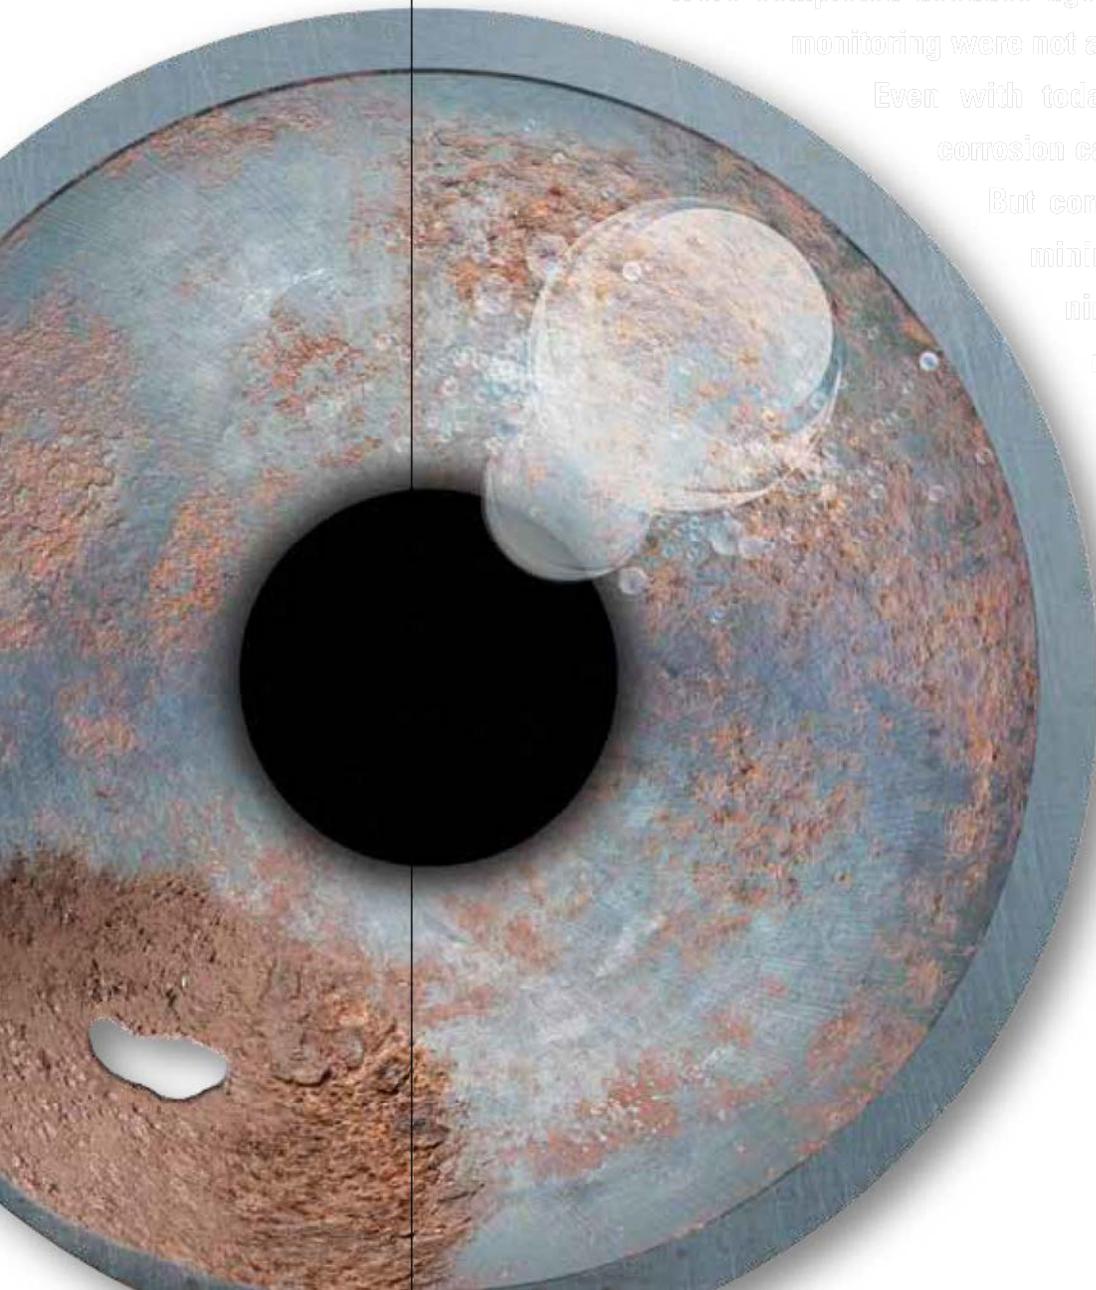
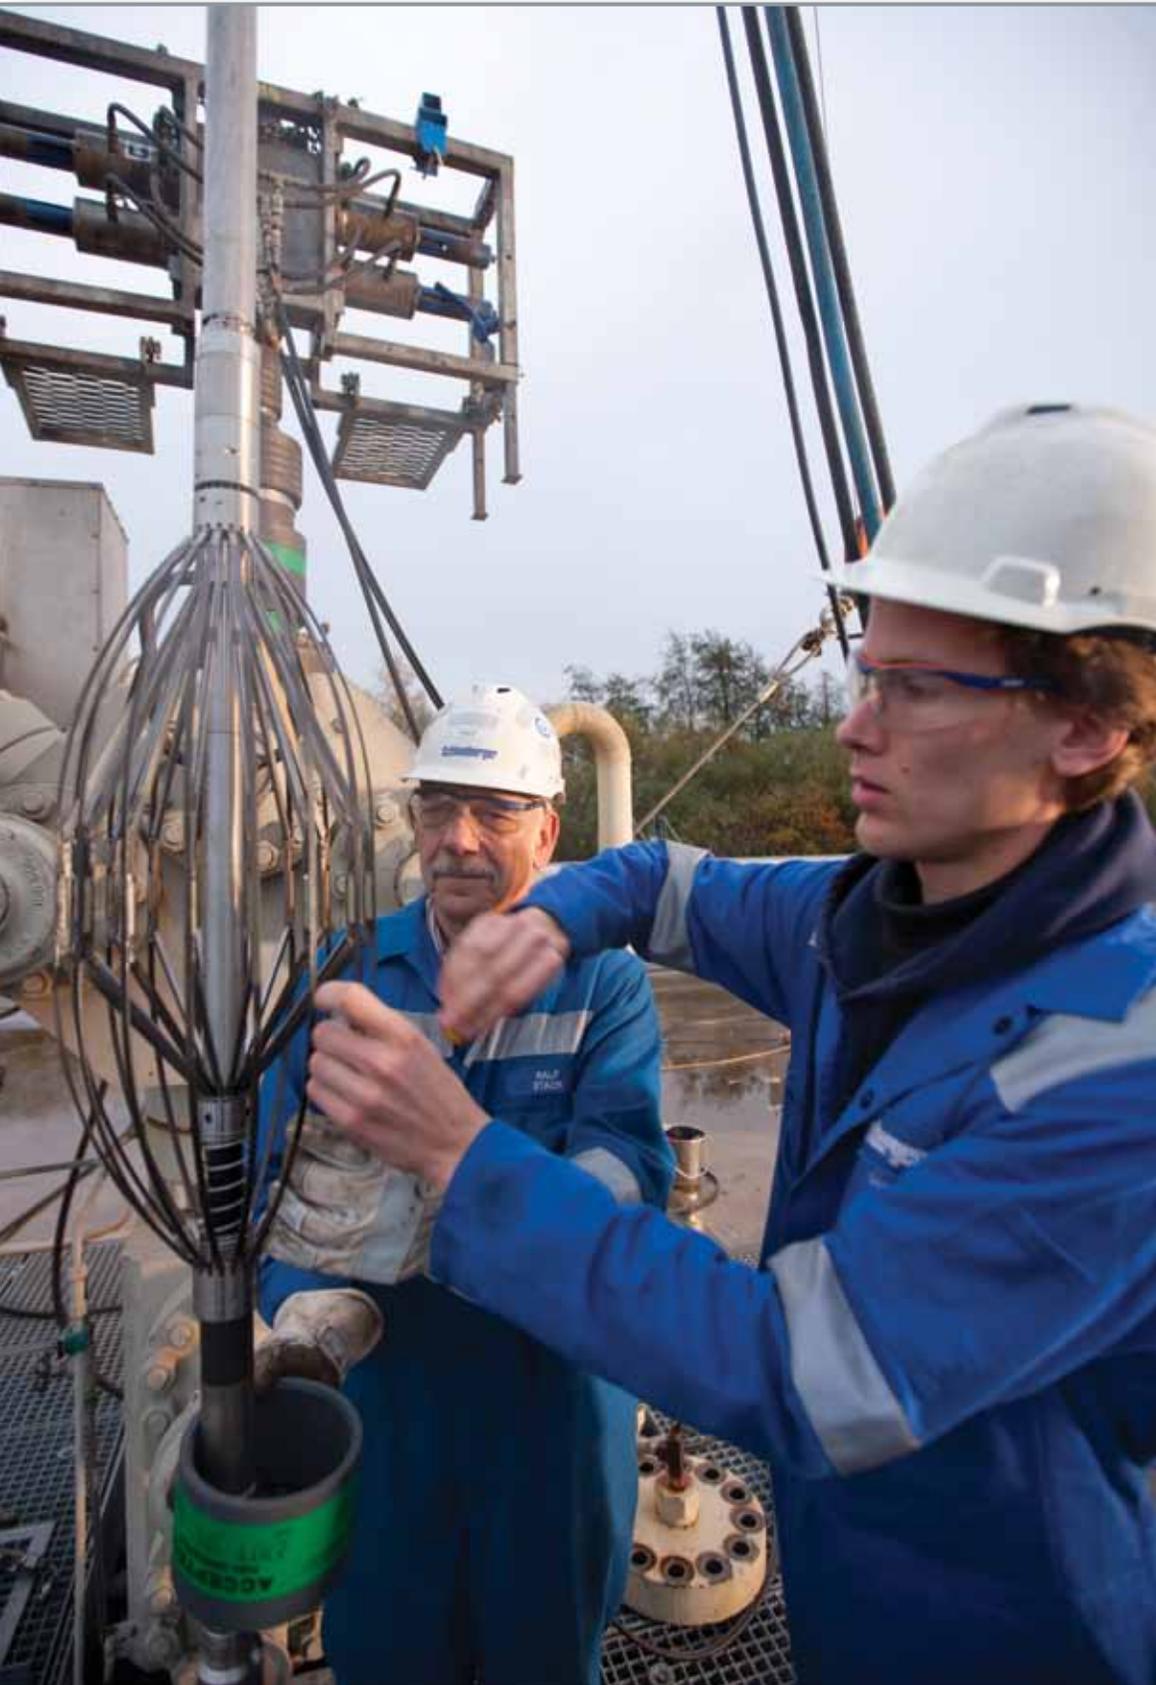
The 18 pad sensors mounted on the centralizer arms of the EM Pipe Scanner tool deliver a low-frequency-EM thickness image and a high-frequency discrimination image.

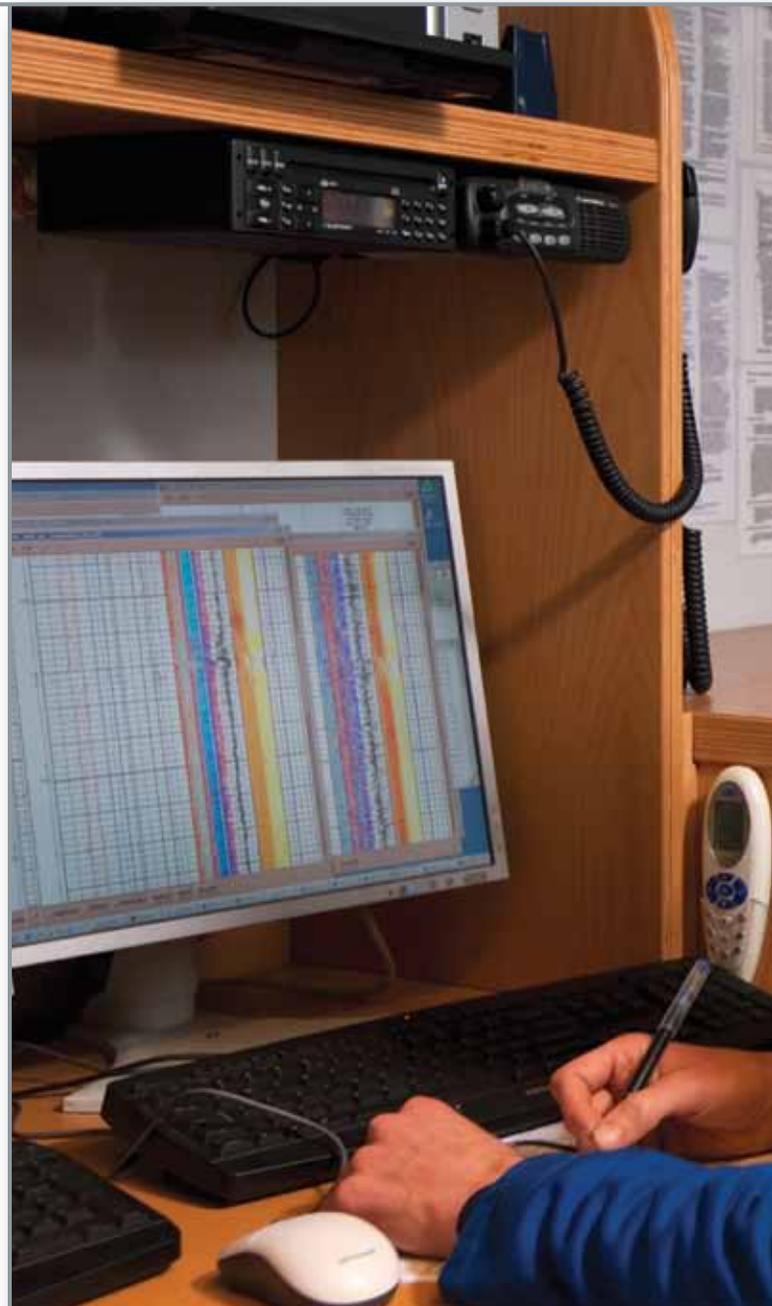
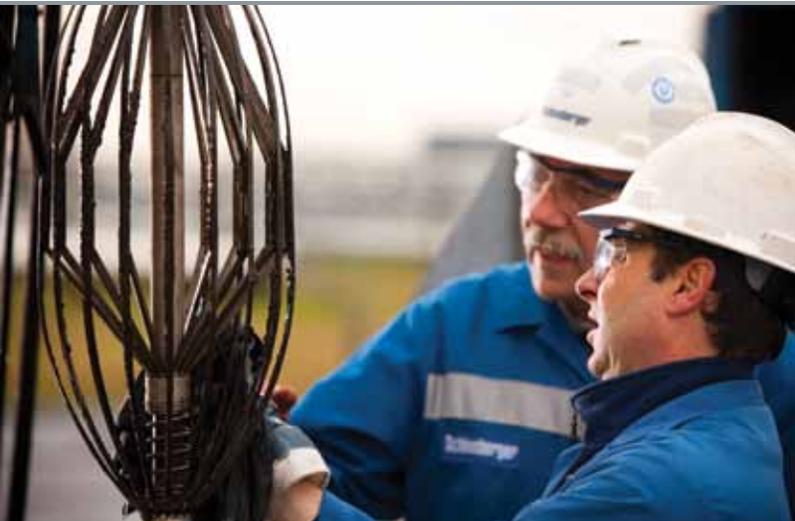
EM Pipe Scanner service was designed with versatility in mind. With a tool OD of just 2.125 in, it makes measurements in pipe ranging from 2 $\frac{1}{8}$ to 13 $\frac{3}{8}$ -in OD. Plus, it can operate in liquid or gas environments.

With a slim 2.125-in [5.4-cm] diameter, the EM Pipe Scanner tool easily passes through tubing to evaluate casing below the tubing shoe and quantify metal loss in percentage and average ID of casing ranging from 2 $\frac{1}{8}$ - to 13 $\frac{3}{8}$ -in OD. Casing up to 9 $\frac{5}{8}$ -in OD is azimuthally imaged by the pad sensors on the tool's imaging section. The tool is fluid insensitive, operating in liquid or gas environments.

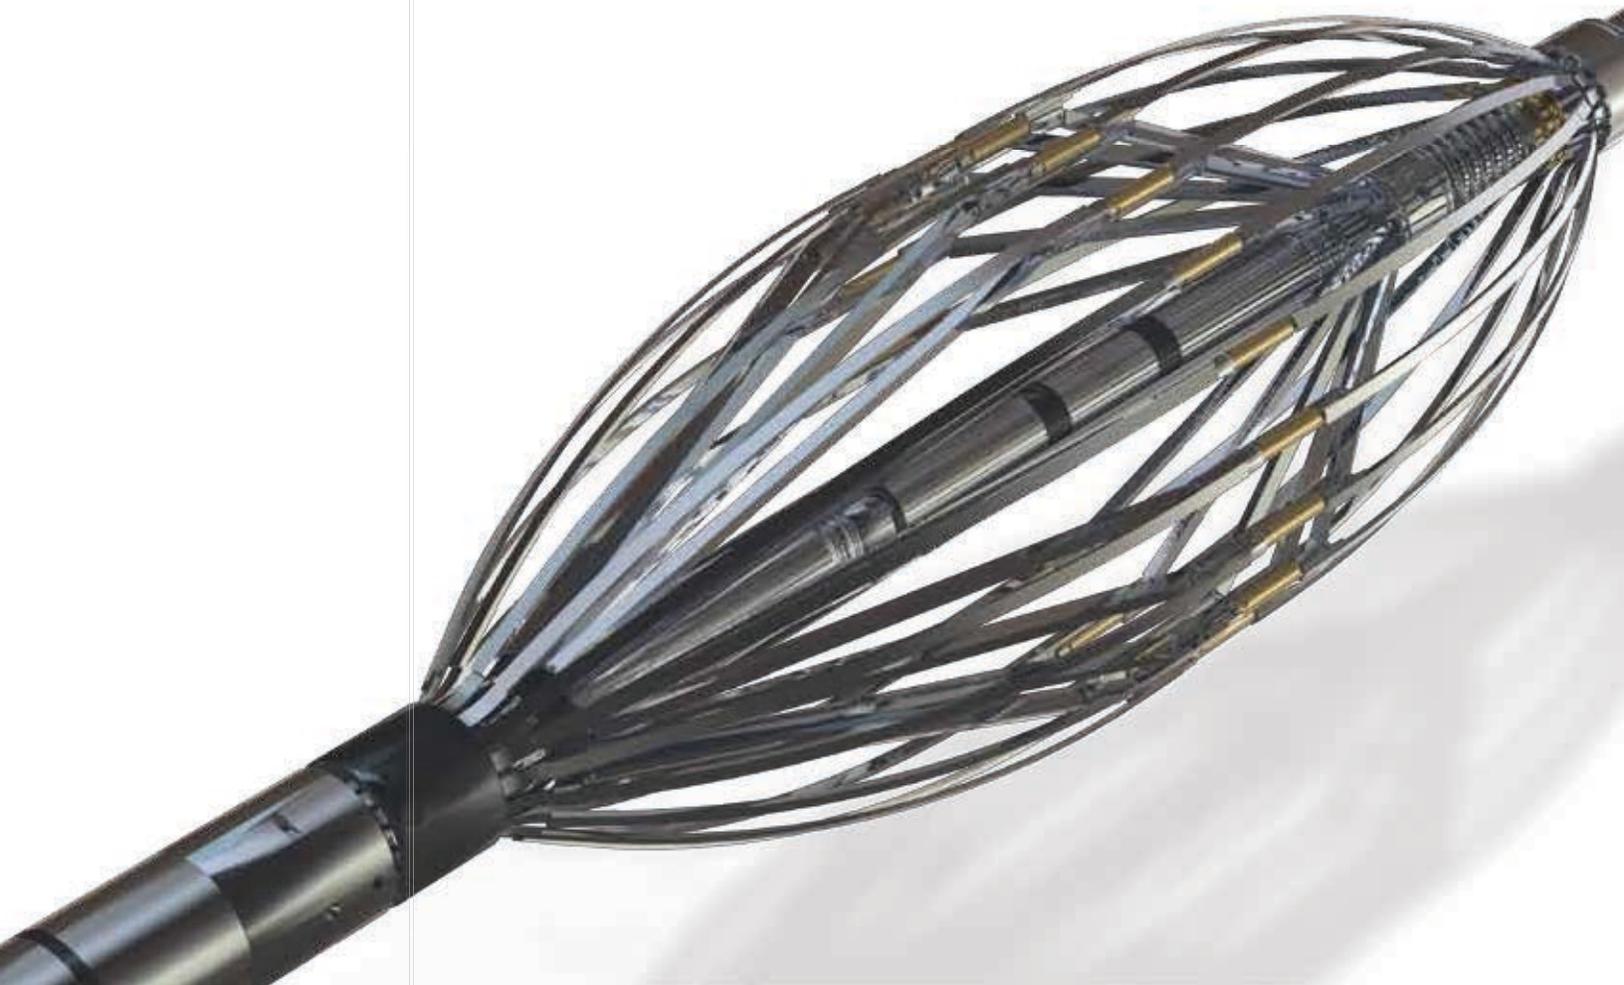
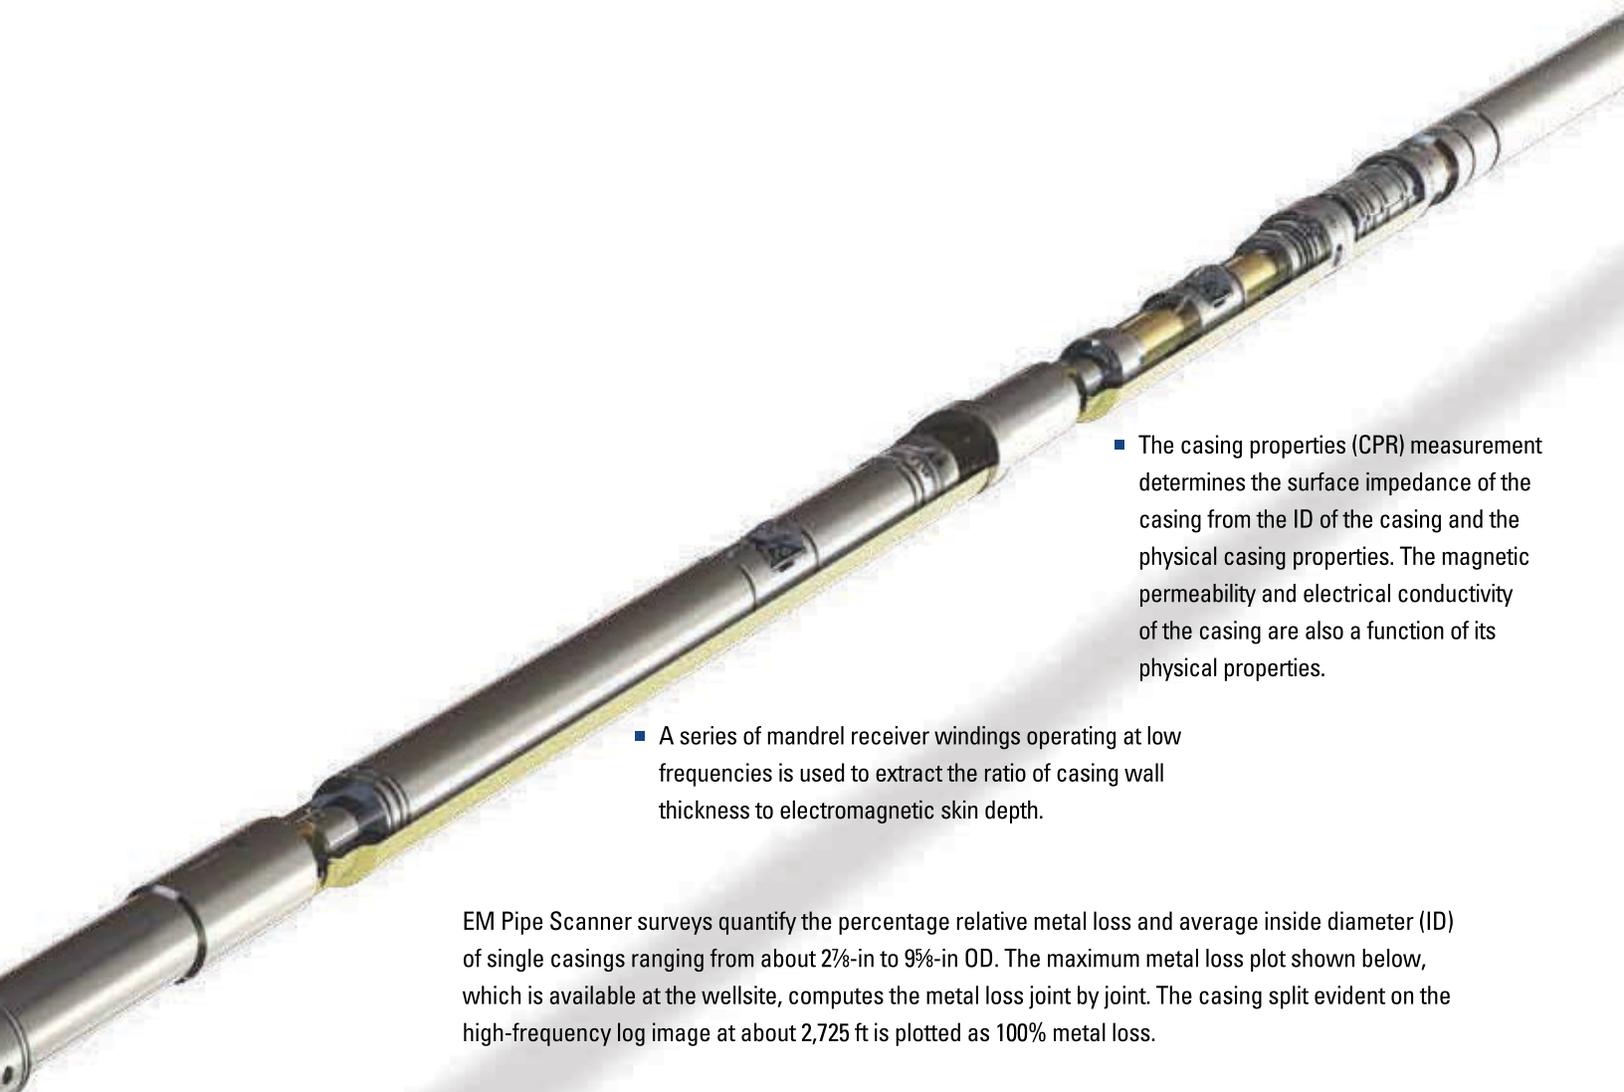
- The imaging section provides two images: a low-frequency-EM thickness image for evaluating the remaining metal and a high-frequency discrimination image produced from 18 pad sensors mounted on the tool centralizer arms. The EM Pipe Scanner high-frequency image provides the status of the internal casing wall, as well as acts as a discriminator for defects in the inner or outer wall of single casing strings. In the log shown, the high-frequency image clearly identifies a groove in the internal wall of the casing as vertical black traces on the left side of the image. In addition, a casing split is obvious at 2,725 ft, in the middle of the joint body. A defect such as a casing split that has spread through the internal wall to the external wall of the casing is also depicted on EM Pipe Scanner low-frequency image.

The EM Pipe Scanner tool uses three types of noninvasive EM measurements to characterize well casings. These nondestructive induction methods employ both low- and high-frequency induction currents. Metal loss and changes in casing geometry are detected by combining the three measurement types:

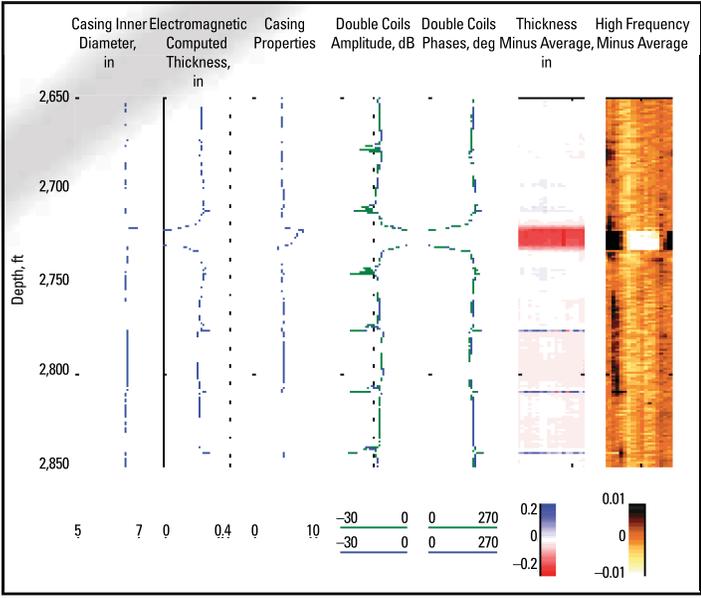
As part of the detailed EM Pipe Scanner casing summary report available for single-string surveys, maximum metal loss per joint is plotted at the wellsite.

EM Pipe Scanner surveys quantify the percentage relative metal loss and average inside diameter (ID) of single casings ranging from about 2 $\frac{1}{8}$ -in to 9 $\frac{1}{8}$ -in OD. The maximum metal loss plot shown below, which is available at the wellsite, computes the metal loss joint by joint. The casing split evident on the high-frequency log image at about 2,725 ft is plotted as 100% metal loss.

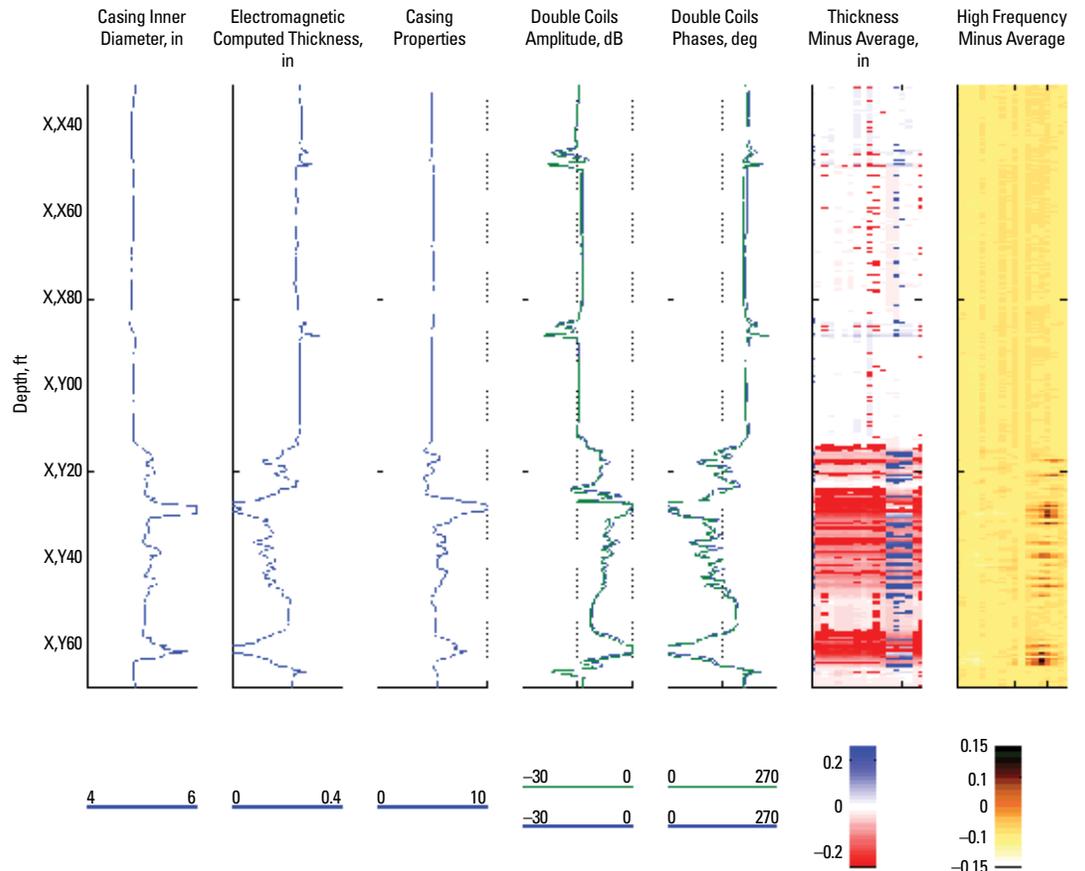
The EM Pipe Scanner low-frequency image (second track from right) shows corrosion in the external wall of the 5½-in liner in the perforated interval from X,Y15 to X,Y65 ft. The high-frequency image also images the perforations.

EM Pipe Scanner service revealed unexpected corrosion across the perforated zone in the 5½-in liner of a well. More corrosion is evident on the low-frequency image than the high-frequency one, which is a clear indication that the corrosion started from the outer wall of the liner and is removing metal from the outside to the inside, feeding the invasion of aggressively corrosive fluids from the formation to the metal and adversely affecting production.

The level of detail delivered by the high-frequency image is shown by the readily identifiable manufacturing patterns and the obvious effect of a liner collar at the top of the log. The perforations are also clearly shown in the lower side of the liner.

The thickness computed from the EM Pipe Scanner measurements is consistent with that of 5½-in 15.5-lbm/ft liner with a nominal theoretical wall thickness of 0.275 in below and above the perforated zone.

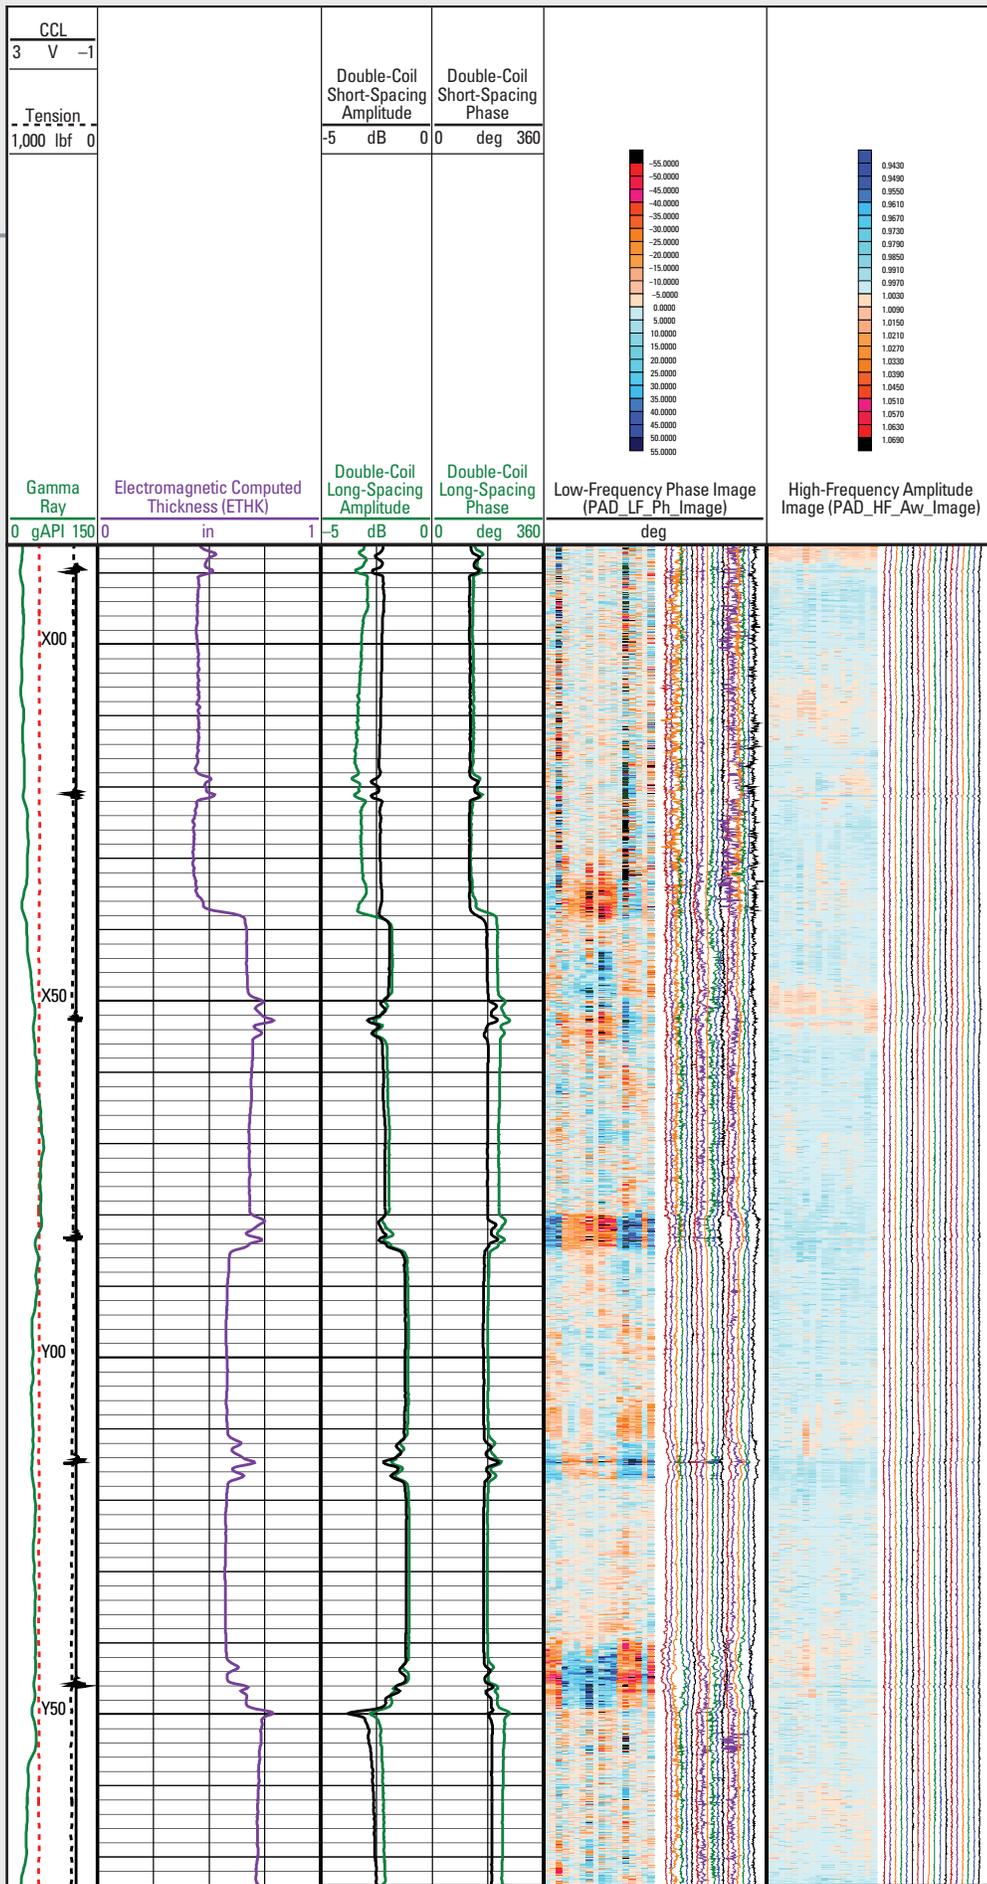
The EM Pipe Scanner ETHK curve identified a change in the weight of the outer 9 5/8 in casing in two joints from X85 to Y50 ft that was not detected by the high-frequency image or PMIT logging.

The EM Pipe Scanner low-frequency image from a double-string section in the same well revealed metal loss on the outer 9½-in casing joint, which was not seen by the high-frequency image or a PS Platform* Multifinger Imaging Tool (PMIT) log.

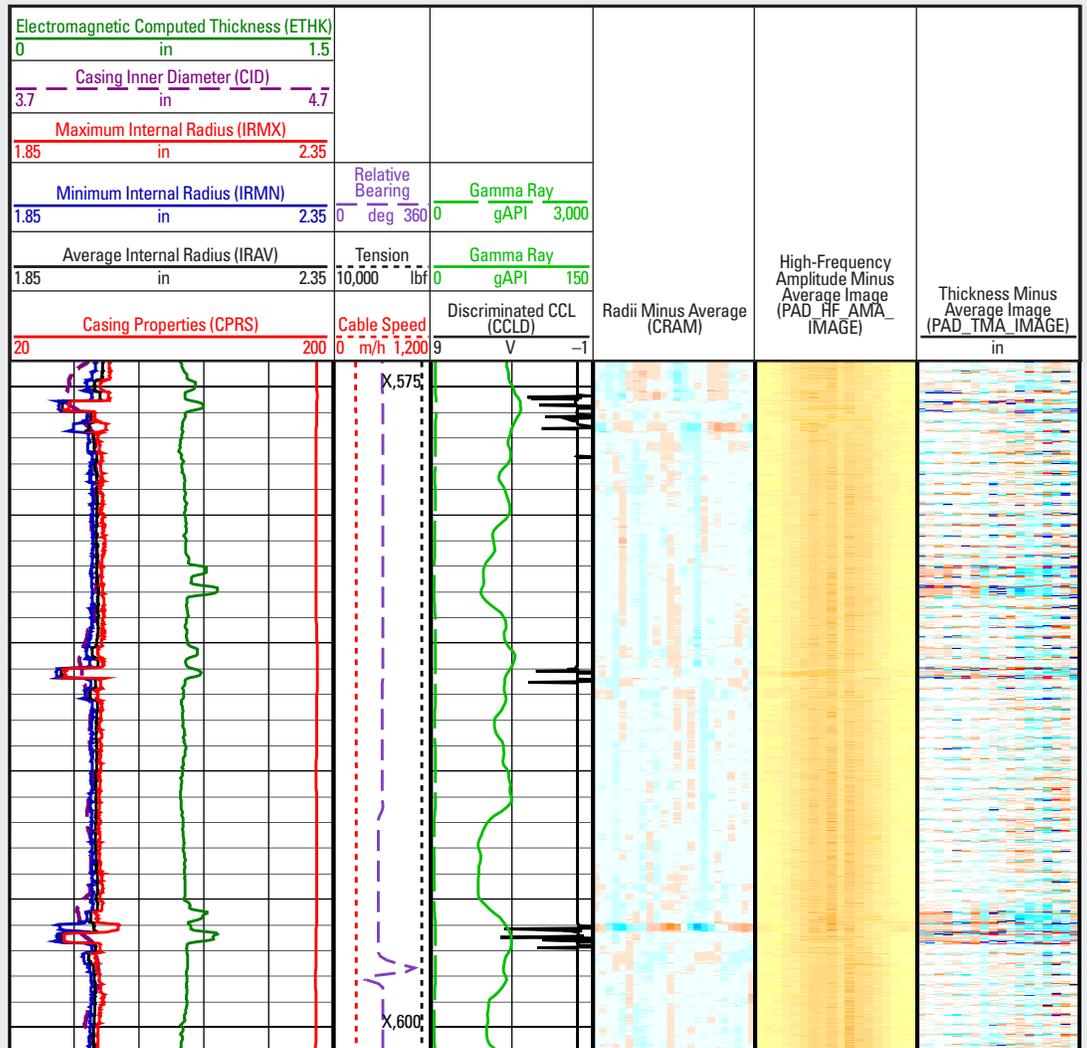
Combining EM Pipe Scanner and PMIT tools in the same string is an effective approach for identifying and evaluating both internal and external casing problems. The PMIT measurements of the internal radius in Track 1 are useful for identifying internal casing problems. EM Pipe Scanner measurement of the total thickness of double pipe in this well is within 5% of the nominal value, providing a good base measurement for future time-lapse monitoring of the casing condition.

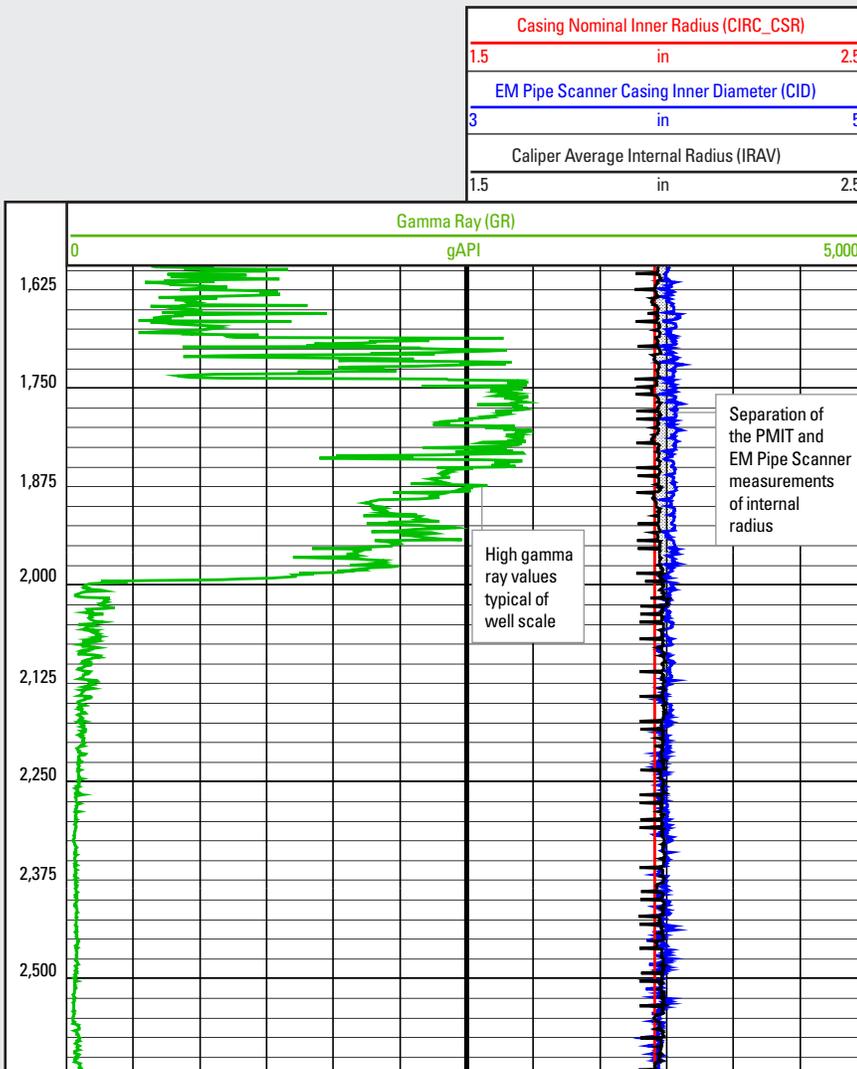
The presence of well scale in 4½-in tubing is indicated by the high gamma ray values and separation of the EM Pipe Scanner and PMIT measurements of the internal pipe radius. The measurements agree well up to 2,033 m, from where they steadily diverge. The difference is used to quantify the scale buildup for monitoring with time-lapse logging.

Multifinger calipers routinely calculate the inner radius from measurement of the inner pipe wall, but the unaccounted-for presence of well scale can impair measurement. In this situation EM Pipe Scanner logging can determine the remaining metal thickness for calculating the ID behind the scale buildup because EM Pipe Scanner measurements are insensitive to nonferromagnetic well scale.
