WELL INTERVENTION: FISHING

Engineered workflow delivers strategy to fish nearly 10,000 ft of CT offshore Mexico

In an unplanned operation, valuable lessons were learned about how effective integration of conventional tools could enable the successful execution of a complex fishing operation with significant equipment restrictions.

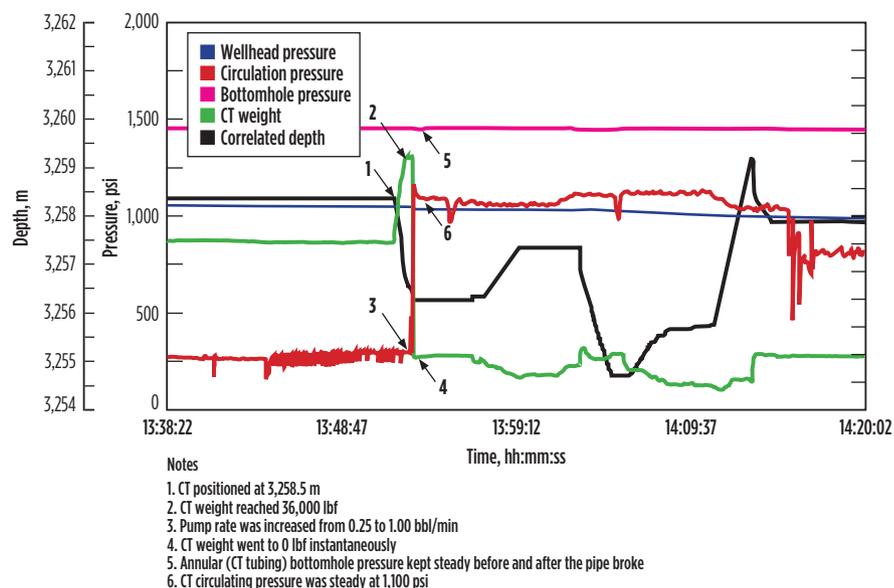
Fig. 1. During up-hole movement for the CT, the CT weight dropped to zero instantaneously.

In January 2016, after reaching the TD of 10,669 ft, the pulling weight of the CT was around 36,000 lbf, the normal pulling weight reached at that depth in the previous 15 runs. However, as the operator prepared to move the pipe up-hole to place the foam at TD, a heavy noise was detected from the WCE, and the pulling weight of the CT suddenly dropped to 0 lbf. In an attempt to retrieve the pipe to the surface, the operator recovered only 653 ft of the CT, leaving 9,977 ft in the vertical section as a fish. The CT that had been such a critical component of a secondary recovery effort had suffered a mechanical failure during the initial stage of the acidizing job, [Fig. 1](#).

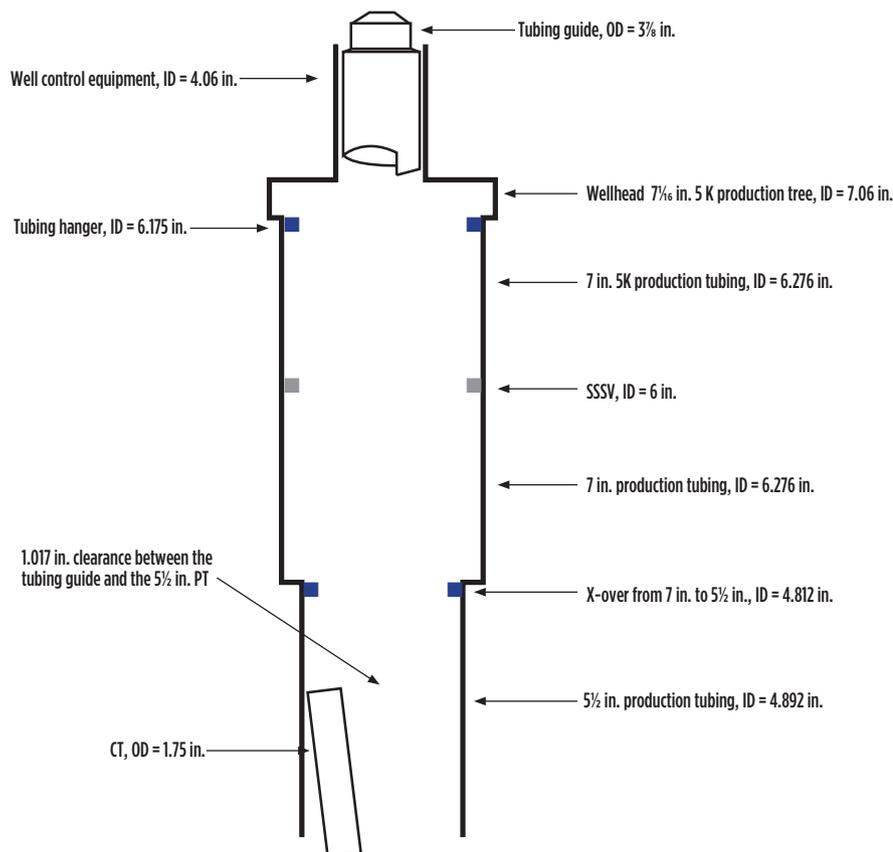
Fig. 2. This well schematic shows CT in the 5½-in. production tubing.

To analyze the well condition and extent of the damage, engineers lowered into the well a 3.75-in. OD lead impression block (LIB). It was designed with a short tube fitted at the lower end and a soft lead insert that makes contact with the obstruction to create an impression. This would provide useful information on the depth of the fish and the type of fishing equipment to deploy, [Fig. 2](#).

The tool initially tagged a restriction at 614 ft, with a second attempt reaching a maximum depth of 692 ft before attaching to the fishing neck. The LIB was retrieved to surface and showed that the pipe was broken and tilted on its side inside the 5½-in. production tubing with an ID of 4.9 in. This left the well with a

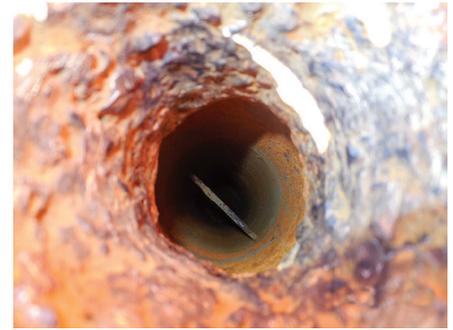
Fig. 3. The milling shoe, before running in hole with bar in place.

Rather than reattempting to contact the tubing edge, the team opted for a different approach that involved centralizing the CT end, using a PDM and $3\frac{5}{8}$ -in milling shoe with an internal bar, Fig. 3. The first run using this configuration was successful. The internal bar inside the milling shoe was broken, meaning centralization was occurring, Fig. 4. However, this action had damaged the pipe.

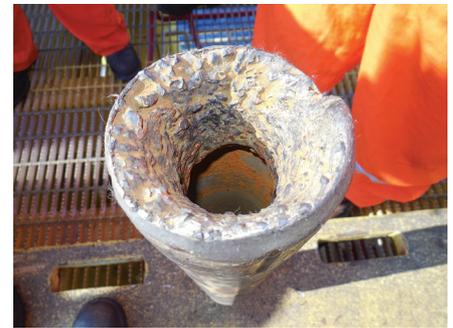
Fig. 4. The milling shoe after being pulled out of hole without inner bar.

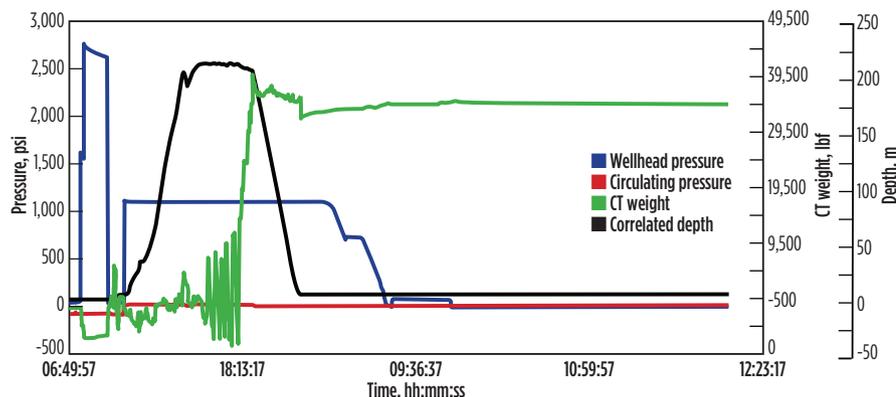
Fig. 5. During the CT recovery, it was noticed that the CT weight increased gradually, indicating a successful latch.

and began the recovery process. After a total of 43 runs over 20 days, the 9,977-ft CT pipe was recovered to the surface, with the CT weight gradually increasing from 0 to 39,000 lbf, Fig. 5.
