# Alaska: The MAGNOSTAR magnet tool demonstrates its effectiveness in removing milled solids from the wellbore, prior to sidetracking operations.

## Well Information

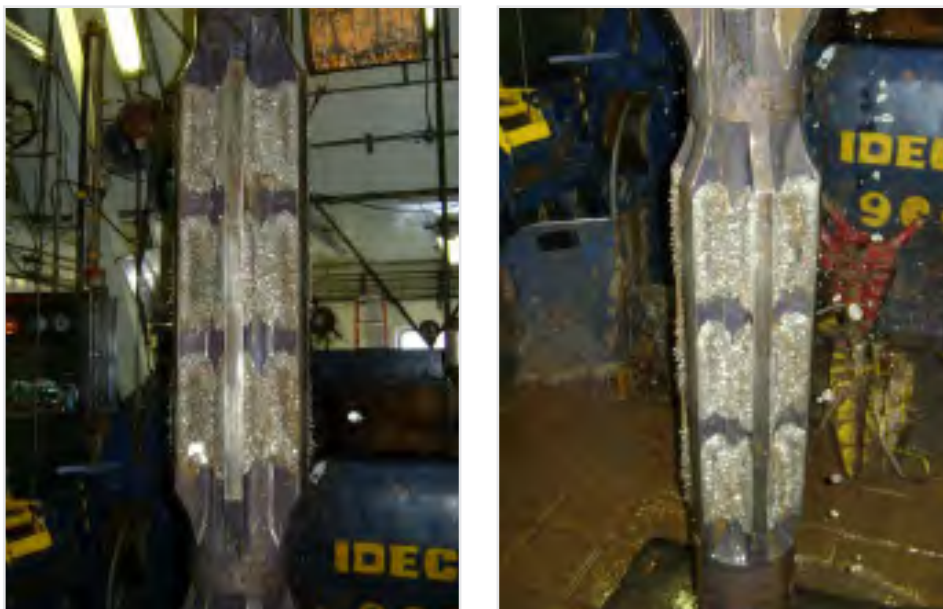
MAGNOSTAR tools loaded with debris

The main clean-up BHA was run to depth, once on bottom, a weighted hi-vis sweep pill was circulated at 11.0 bpm with 1,025 psi SPP and displaced with 9.6 lb/gal (1.15 SG) LSND (Low-Solids, non-dispersed) mud while reciprocating the drill pipe. The BHA was then pulled from well and 120 lb of metallic debris was recovered from the MAGNOSTAR magnets.

The amount of debris captured by the MAGNOSTAR tools during their multiple runs in the hole shows that future downhole operations may have been compromised if the magnetic debris had been left in the wellbore. The MAGNOSTAR tool has provided a simple solution to reducing these risks.
