ZEiTECS Shuttle System Saves USD 95,000 and 5 Days of Deferred Production to Replace ESP

After 520 days in the well, the REDA ESP system was replaced rapidly with an integrated coiled tubing operation rather than a workover rig, Ecuador

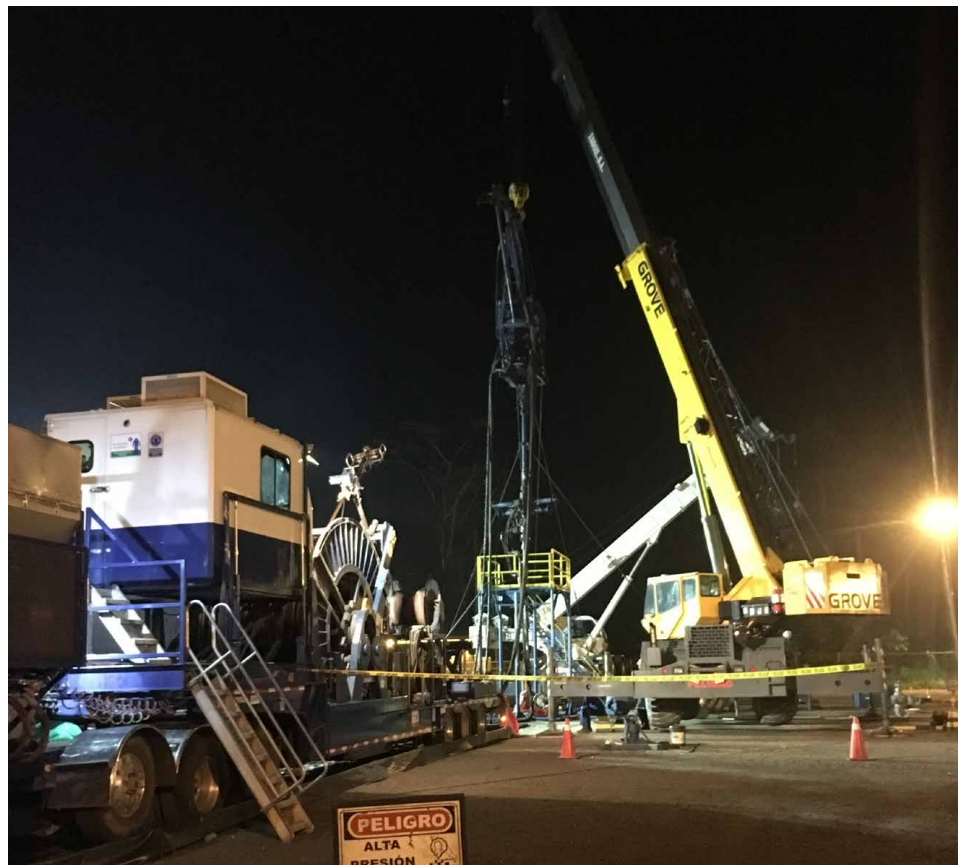
The ZEiTECS Shuttle system enabled rapid ESP replacement without a workover rig, reducing costs and eliminating more than 5 days of deferred production.

The ZEiTECS Shuttle system consists of a downhole docking station and retrievable ESP string. The docking station is attached to the end of the tubing. Inside the docking station are three connectors and landing shoulders that support the weight of the ESP and its reactive forces and prevent the motor from counter-rotating on startup. The retrievable ESP string is made up of a motor connector, standard ESP assembly, and a bypass valve. The motor connector contains female wet connectors and has corresponding parts to orient and connect the ESP to the docking station, intake and discharge, as well as a bypass valve to allow fluid to drain on system retrieval.

Coiled tubing was rigged up to the well to pull the old ESP string through the tubing without a workover rig. The new ESP was subsequently run into the well using the same tool. When the ESP reached the ZEiTECS Shuttle system's docking station, the motor connector automatically orientated and connected, providing the electrical source to enable powering up.
